PROGRAM TITAN IIIM
STANDARD SPACE LAUNCH VEHICLE
DEVELOPMENT REPORT
FOR
STAGE I ENGINE DEMONSTRATION TESTING

Report 9180-941-DR-9

31 March 1969

Aerojet-General Corporation
Liquid Rocket Operations
Sacramento, California
95809

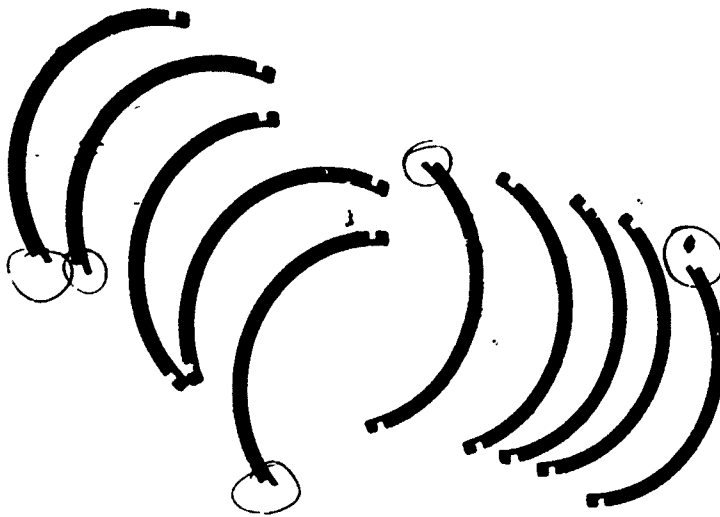
Figure 73 -- Bearing Spacer -- S/N 477

All spacer failures occurred at the corner of the square rod and were tensile type failures (see Figures 73 and 74). A high tensile load on the spacers can only occur when the spacer is restrained from progressing with the rollers. This restraint occurs when rollers become skewed, thereby forcing the spacer against the side of the spacer groove in the inner race. The detached spacer end is contained in the spacer groove by the gimbal lubricant which prevents it from wedging the roller bearings. No redesign activity is recommended at this time.

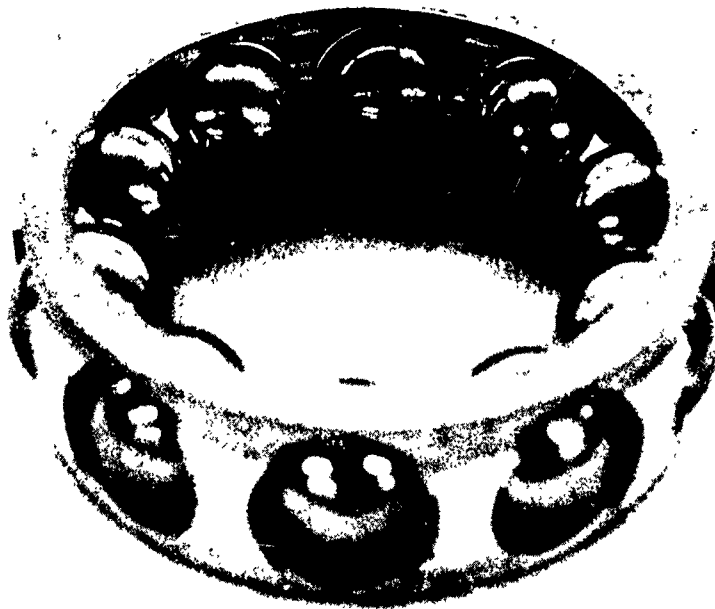
Figure 76 -- Bearing B-10, S/N 1462 -- Balls and Cage

stained (see Figures 75 through 80). This condition had not been observed, however, when the turbopump was disassembled approximately four weeks earlier. For this reason it is concluded that the staining occurred following the disassembly when the parts were exposed to the atmosphere. This is substantiated by the fact that the staining occurred in areas where the rolling elements contacted the races while at rest. In accordance with the display preparation the parts were retained in the as-is condition; that is they were not cleaned or protected with preservative.

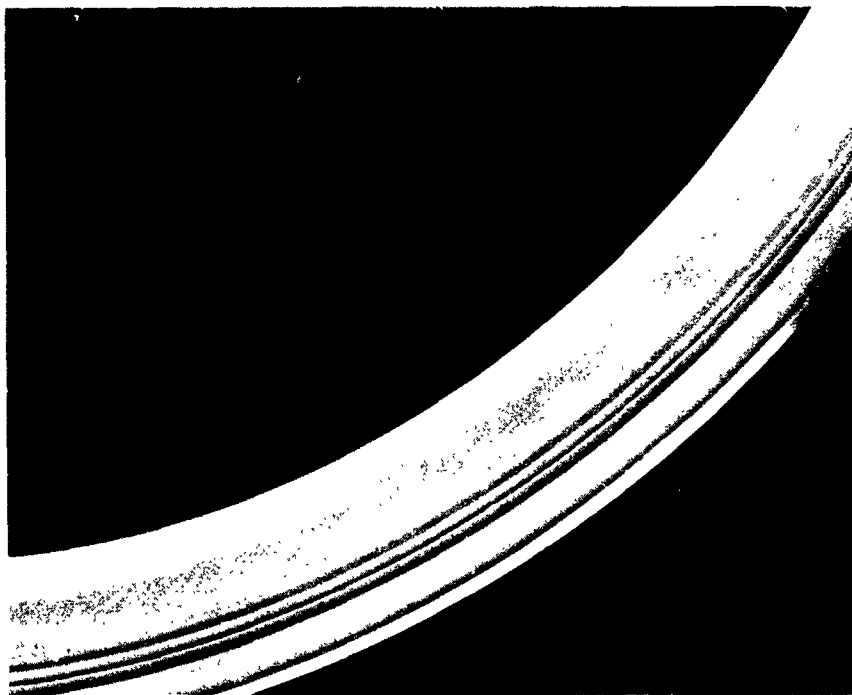
Figure 81 -- Lip Seal -- S/N 0010006

Seals S/N 0010006, S/N 0010008, and S/N 0010009 were analyzed after they were removed from engine S/N 14. There were intermittent circumferential flexural stress cracks in the bend area of seal S/N 0010006 which were initiated at the downstream surface and were approximately one-third through the lipseal thickness (see Figure 81). The lipseal material (CTFE) had a slight to moderate yellow green tinge. Five hardness readings taken were 8.7, 8.6, 8.6, 8.8 and 9.0.

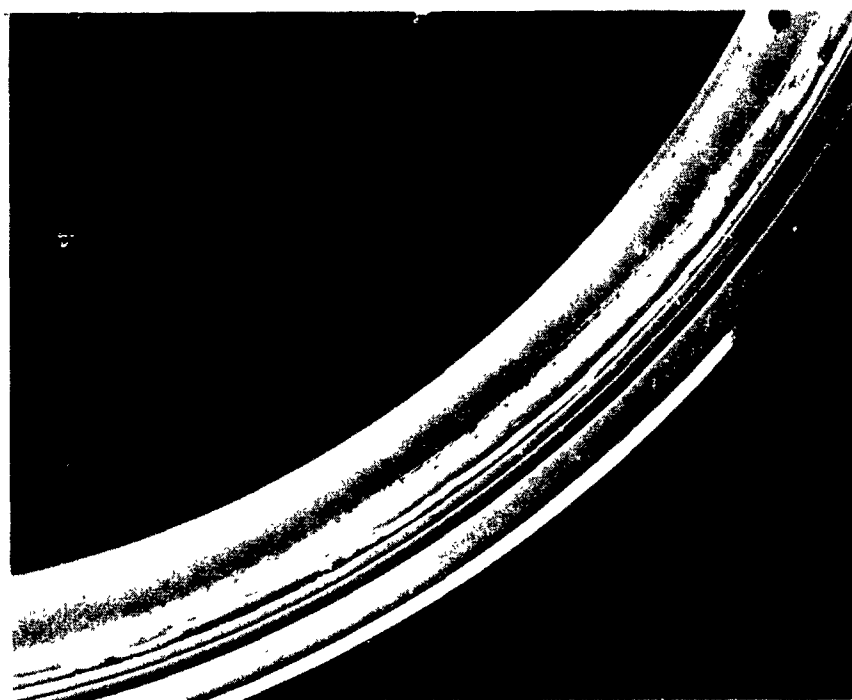
Figure 82 -- Lip Seal -- S/N 0010008

There were connecting circumferential flexural stress cracks in the bend area of seal S/N 0010008 which were initiated at the downstream surface,

and approximately thirty percent of the cracking was all the way through the lipseal thickness (see Figure 82). The lipseal material (CTFE) had a slight yellow tinge. Five hardness readings taken were 8.9, 8.9, 8.7, 8.4 and 8.2.
